# Manhole Inspection Summary

Manhole # S43I2\_010MH

Insp Date: **1/2/08 1:49 PM**

**Location** Address: **W Bay Ave**

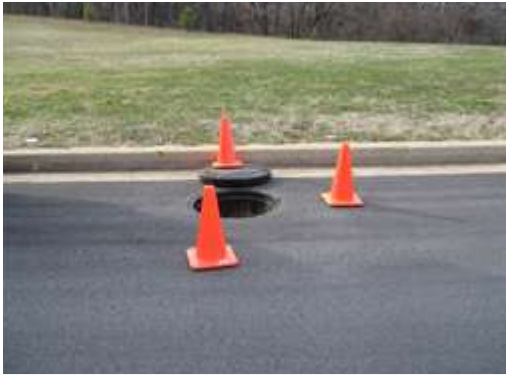
Location View

West Bay Ave.

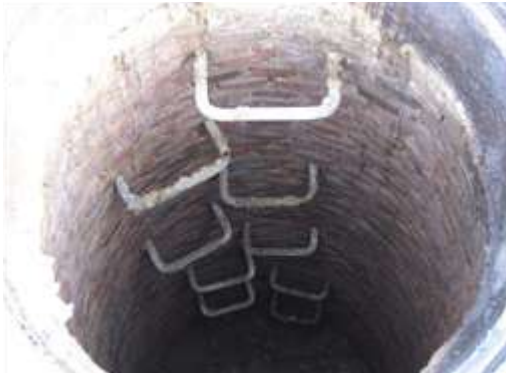
Steps

**Steps** Count: **9** Missing: **0** ☐ Corroded

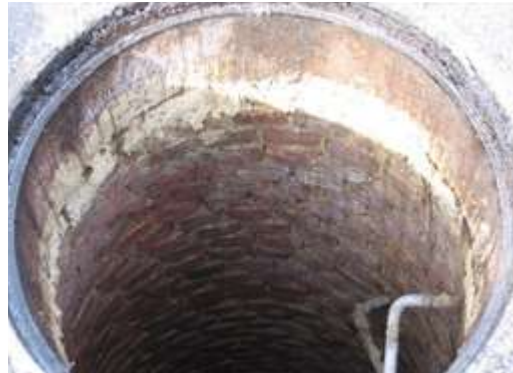
Defect 2

Infiltration: ☐ None ☐ Joint ☒ **Cracks** ☒ **Mortar** ☐ Roots ☐ Wall

Mortar/Cracks

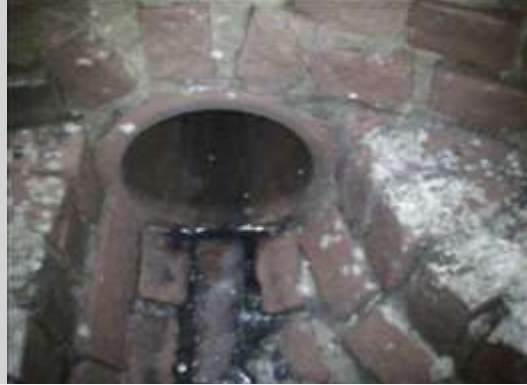
12 O'Clock Outflow

8 in. Circular Gravity Sewer  
Pipe Out @ 12 O'Clock

Pipe Material: **Clay** ☐ Pipe Lined

Deposits: ☒ None ☐ Mud ☐ Sludge ☐ Debris ☐ Grease

Infiltration: **None** Pipe Seal Cond: **Sound**

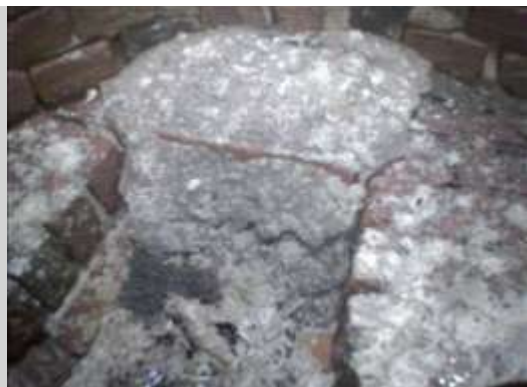
3 O'Clock Inflow

6 in. Circular Gravity Sewer  
Pipe In @ 3 O'Clock

Pipe Material: **Clay** ☐ Pipe Lined

Infiltration: **None** Pipe Seal Cond: **Unknown**

Connects To: **House connection / Service line**

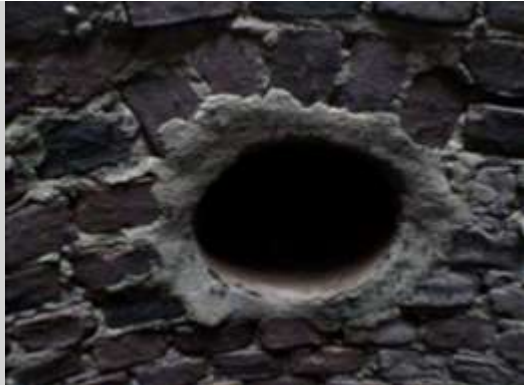
6 O'Clock Inflow

8 in. Circular Gravity Sewer

Pipe In @ 6 O'Clock

Pipe Material: **Clay** ☐ Pipe Lined

Infiltration: **None** Pipe Seal Cond: **Sound**

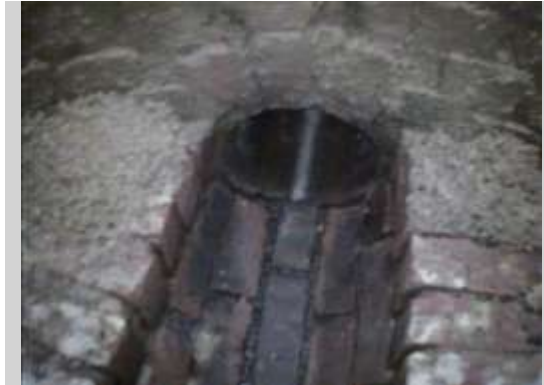
Drop In @ 6 O'Clock

Drop: **Outside** Rod and Bar

Angled: **Yes** Reading: **14.05** (ft.)

Inv Depth: **15.05** (ft.)

Drop Condition: **Open**
